Lynden Garden MESP Erosion Hazard and Mitigation Assessment

**299 Lynden Road,
City of Brantford**

December 5, 2023
PN22045

Project Number: PN22045
Status: **Draft**
Version: 2.0
Submission Date: December 5, 2023

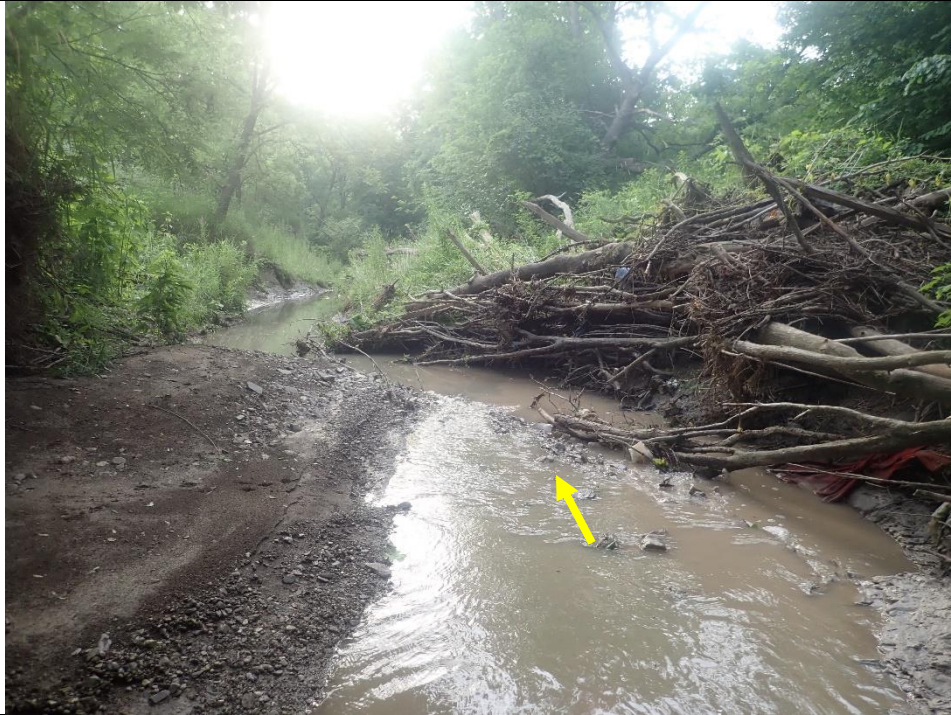
Photo 3
Reach SC-A-5 – Silver Creek, Lynden Road, Brantford

Riffle-pool sequencing was well established and bed materials ranged from exposed till to cobbles.

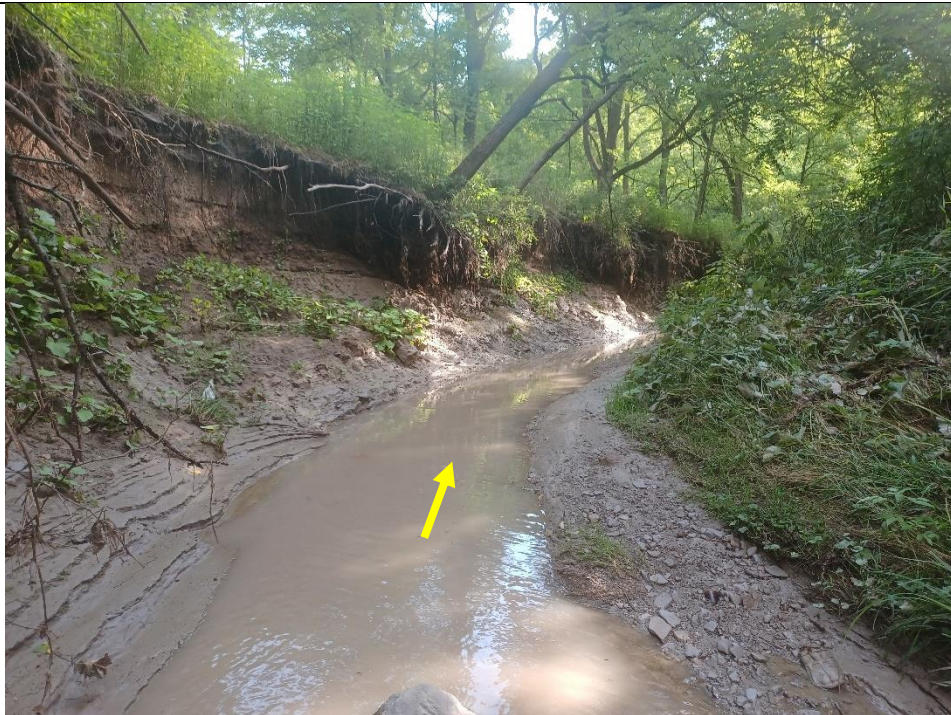
Photo 4
Reach SC-A-2 – Silver Creek, Lynden Road, Brantford

Riparian conditions are characterized by continuous coverage of mature trees, woody debris was commonly observed in the cutbank.

Reach SC-A-2 was situated within a confined valley. Leaning trees and undercutting were observed frequently, indicating evidence of channel widening.

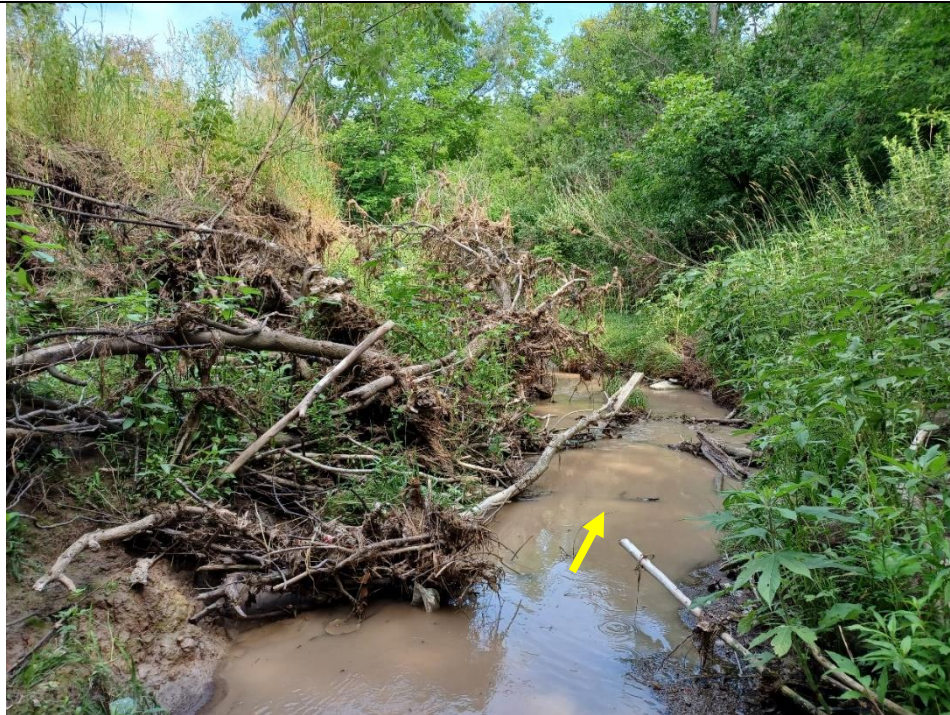
Photo 9
Reach SC-A-3 – Silver Creek, Lynden Road, Brantford

Riffle-pool sequencing was present with bed materials ranging from clay and silt to cobbles in the riffles and clay, silt and sand in the pools.

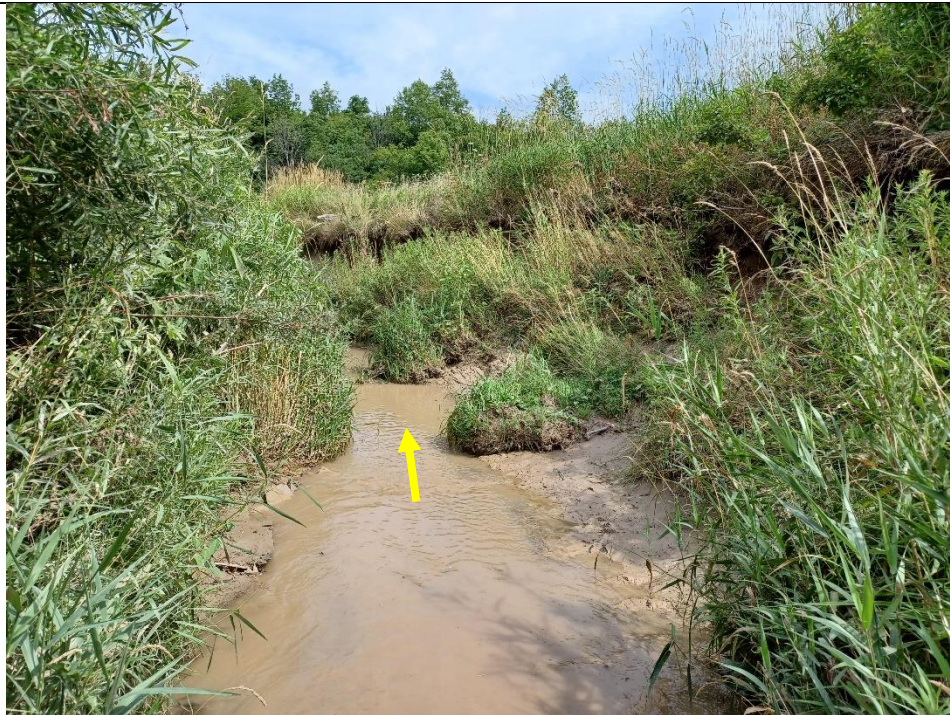
Photo 10
Reach SC-A-4 – Silver Creek, Lynden Road, Brantford

Riparian conditions were characterized as dominated by grasses and herbaceous plants with few mature trees. Bank slumps were commonly observed along this reach.

Reach SC-A-4 had a moderate gradient with irregular meanders and was situated within a confined valley

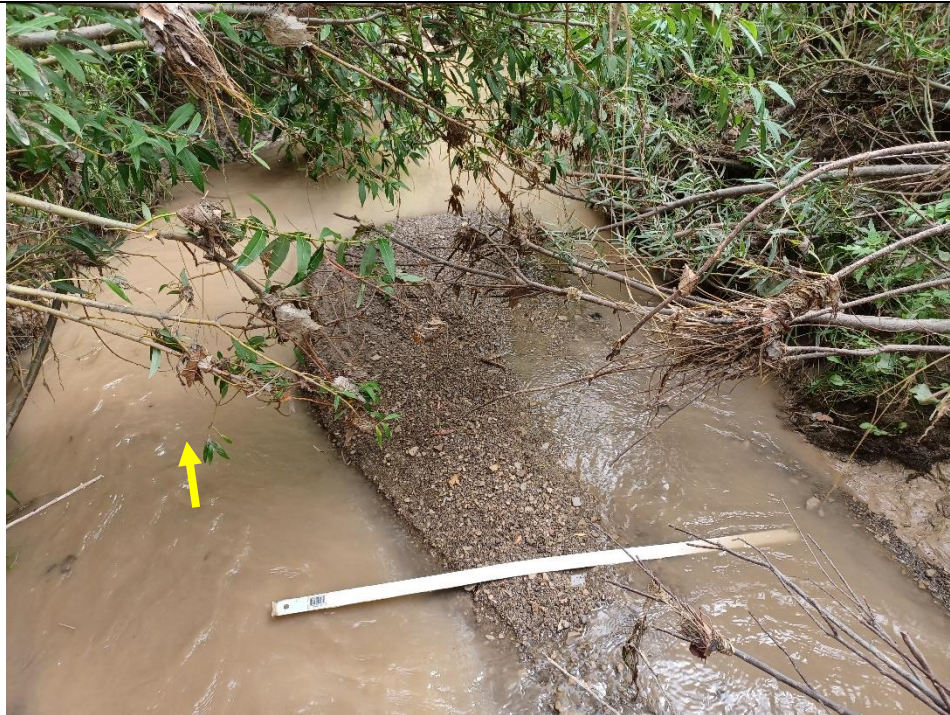
Photo 11

Medial bars, siltation in the pools, and sand deposits in the overbank zone were frequently observed, indicating evidence of aggradation.

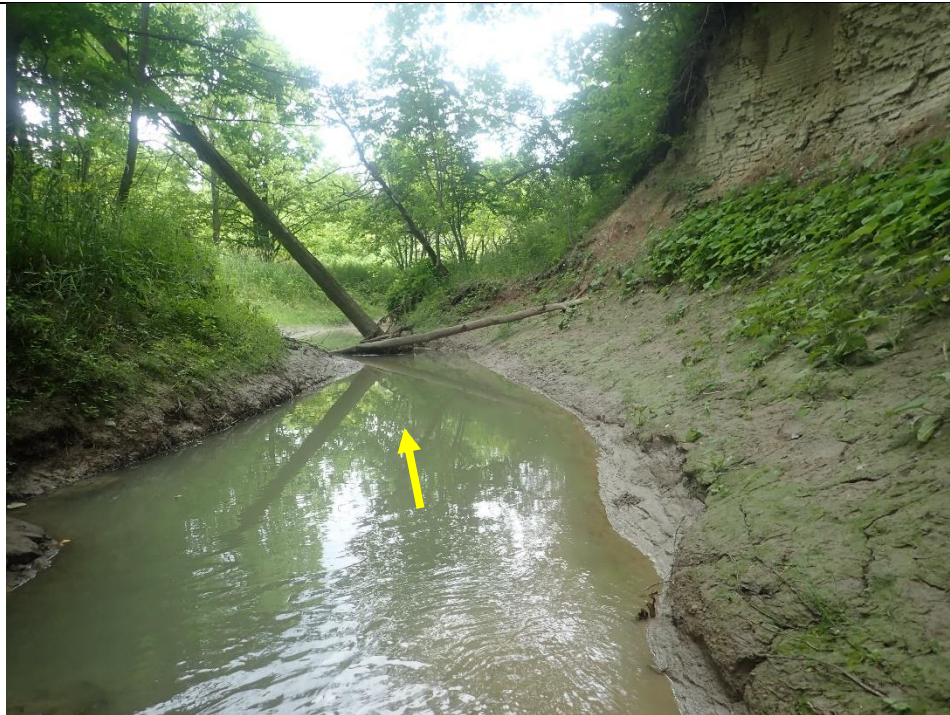
Photo 18

This reach was situated within a confined valley and valley wall contacts were commonly observed.

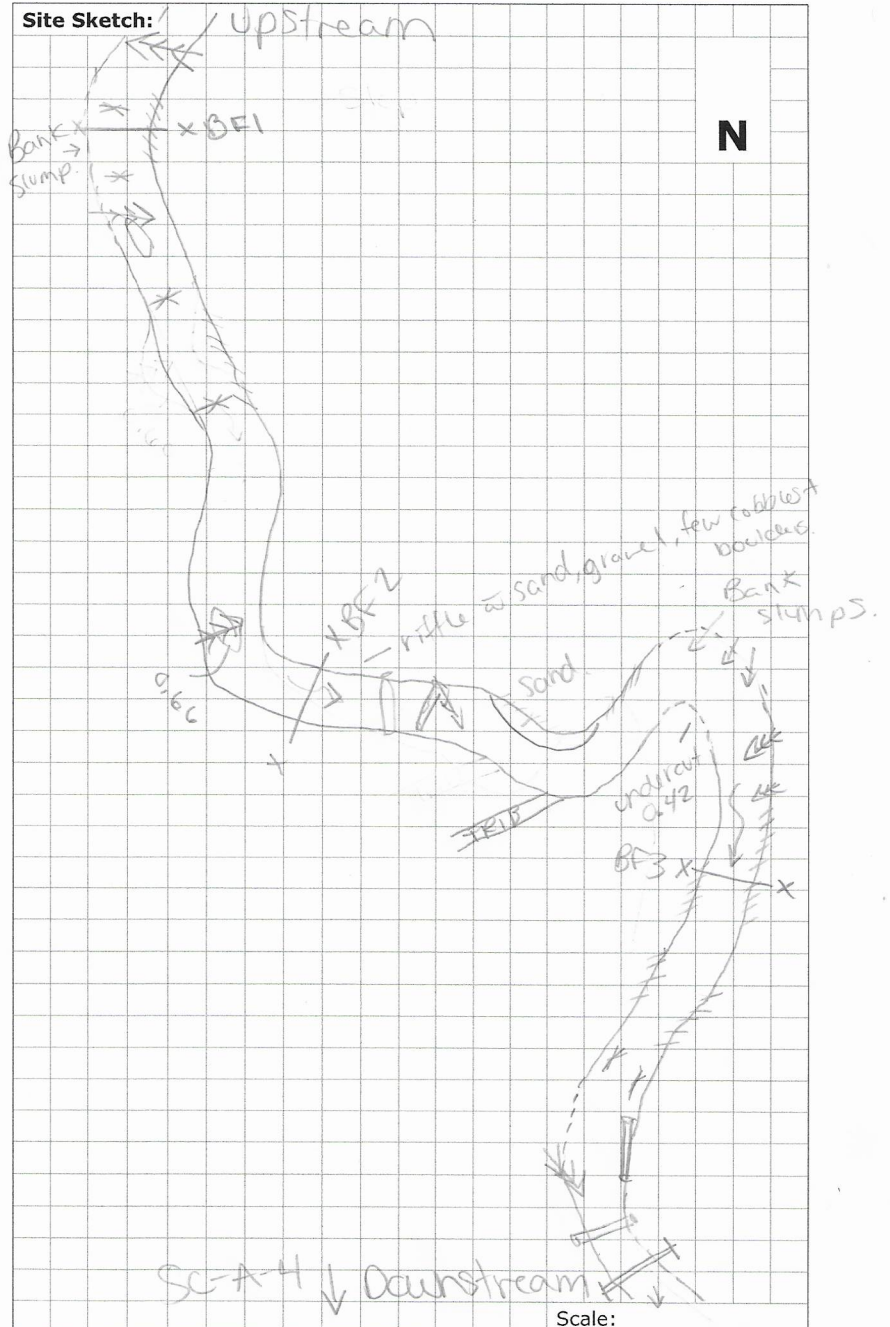
Site Sketch:

- slopes have more grass/herbaceous than previous reaches (less exposed till)
↳ from old bank failures.
- narrower wetted width.
- sand deposits observed on point bars & overbank zone.
