Lynden Garden MESP Erosion Hazard and Mitigation Assessment

**299 Lynden Road,
City of Brantford**

December 5, 2023
PN22045

Project Number: PN22045
Status: **Draft**
Version: 2.0
Submission Date: December 5, 2023

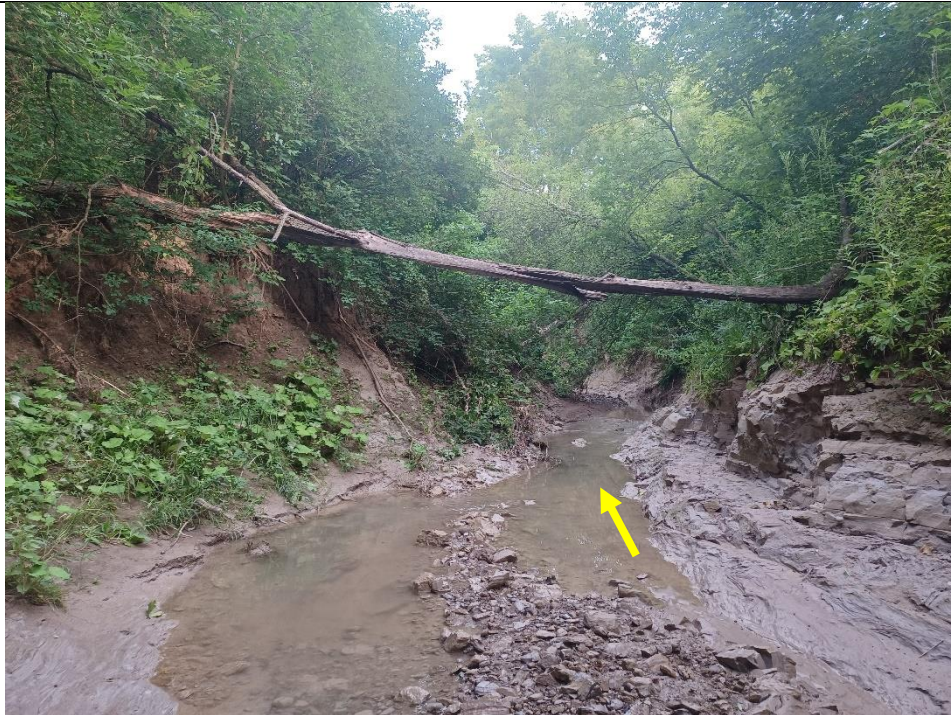
Photo 1

Reach SC-A-1 is highly entrenched and situated within a confined valley. Bank undercutting and valley wall contacts were common. Yellow arrow denotes flow direction

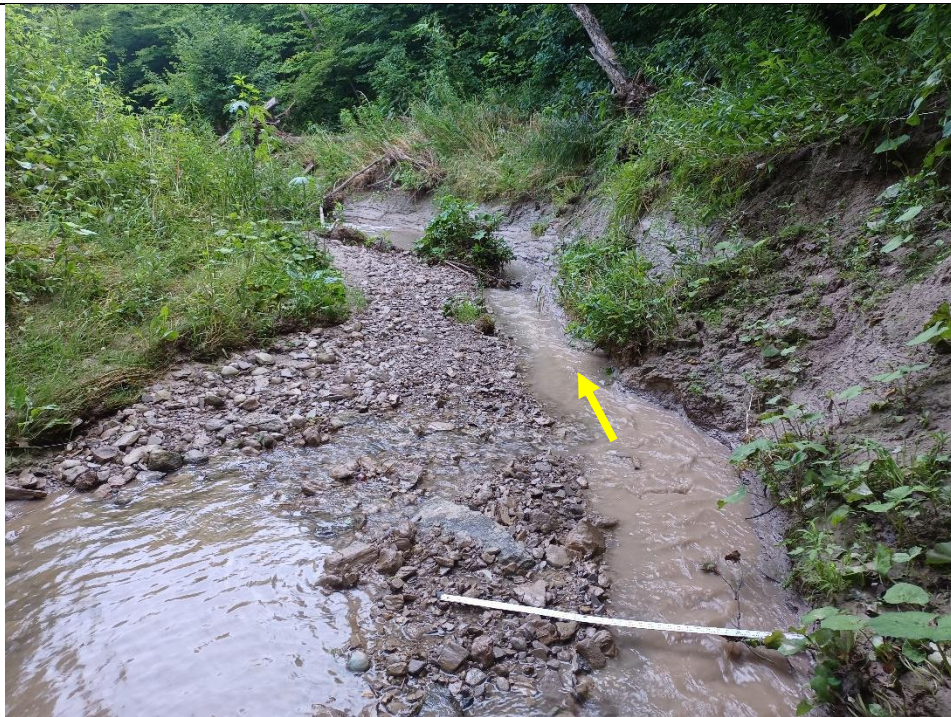
Photo 2

Riffle-pool sequencing was well established and bed materials ranged from exposed till to cobbles.

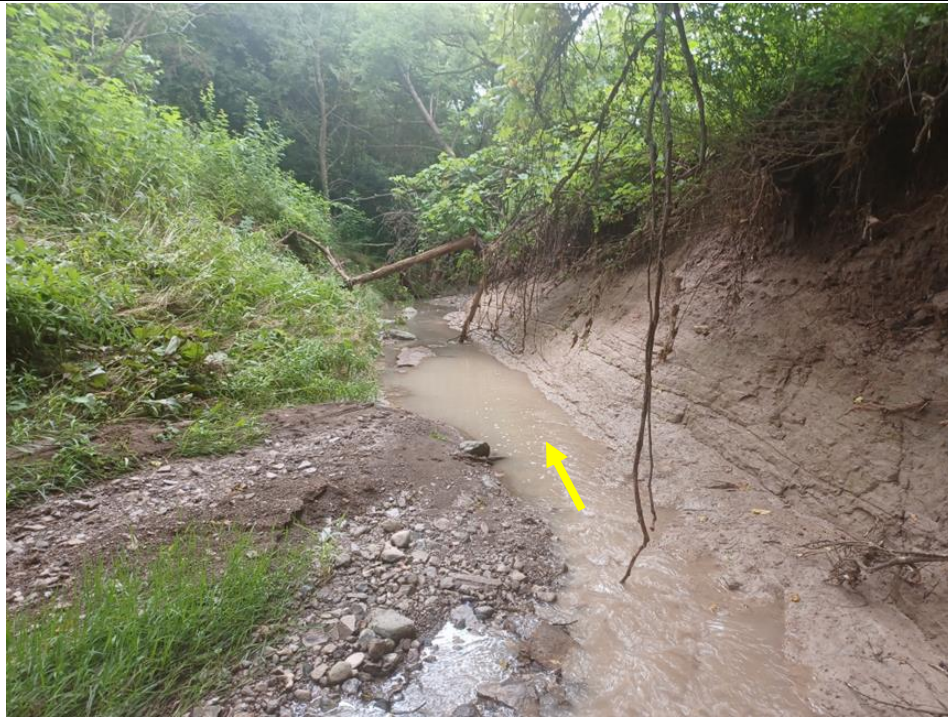
Photo 5

Bank angles ranged from 60° to undercutting and average bankfull widths and depths were 3.6 m and 0.87 m, respectively.

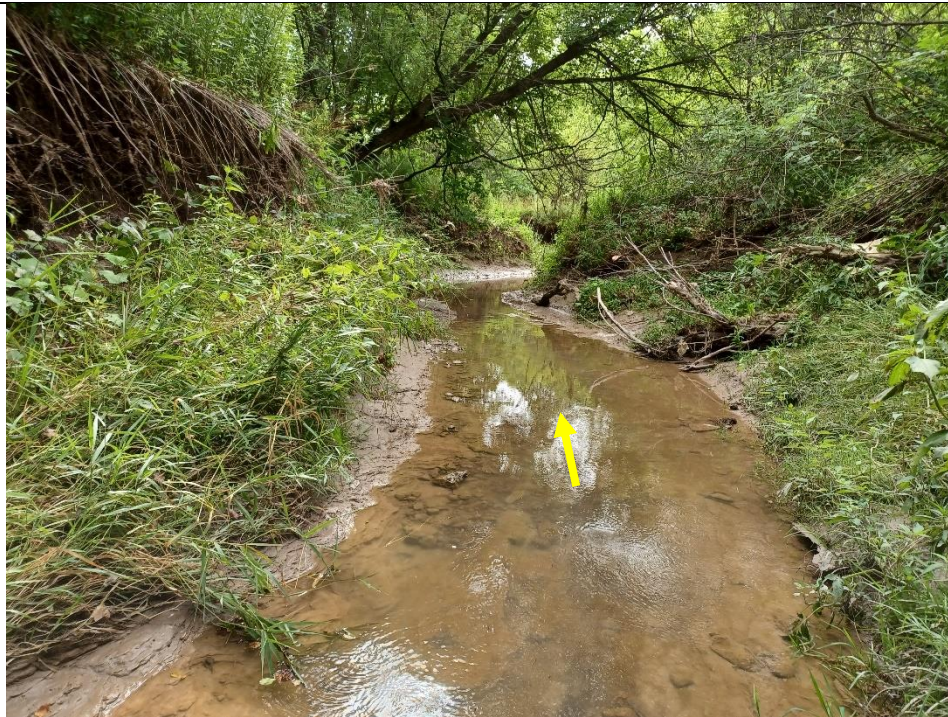
Photo 6

This Reach had a moderate gradient and was highly entrenched.

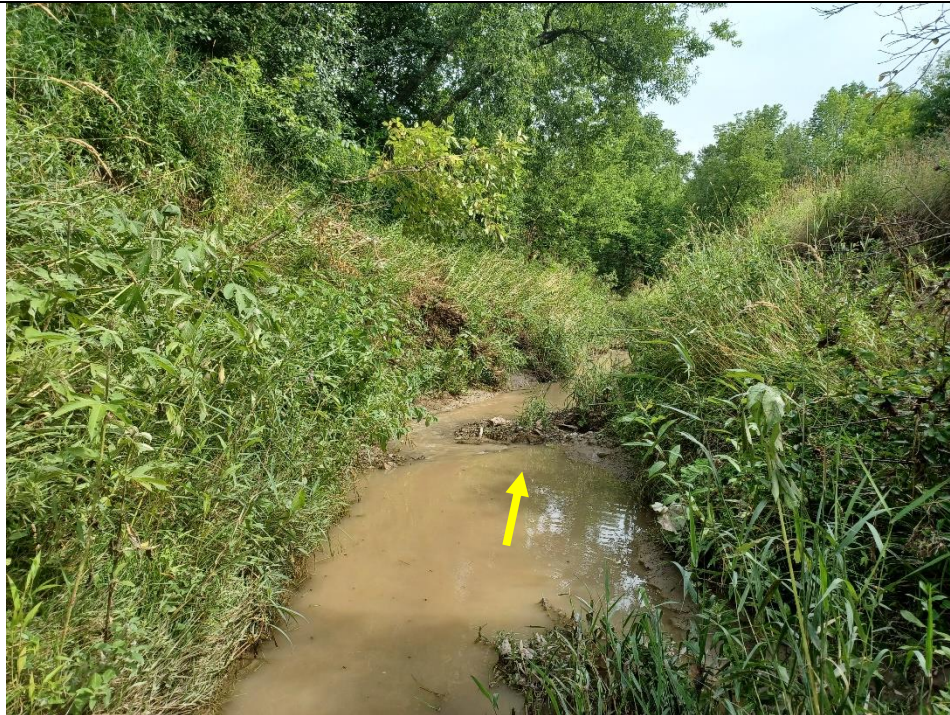
Photo 7

Reach SC-A-3 was situated in a confined valley. Surrounding land use was characterized as forests and agricultural lands.

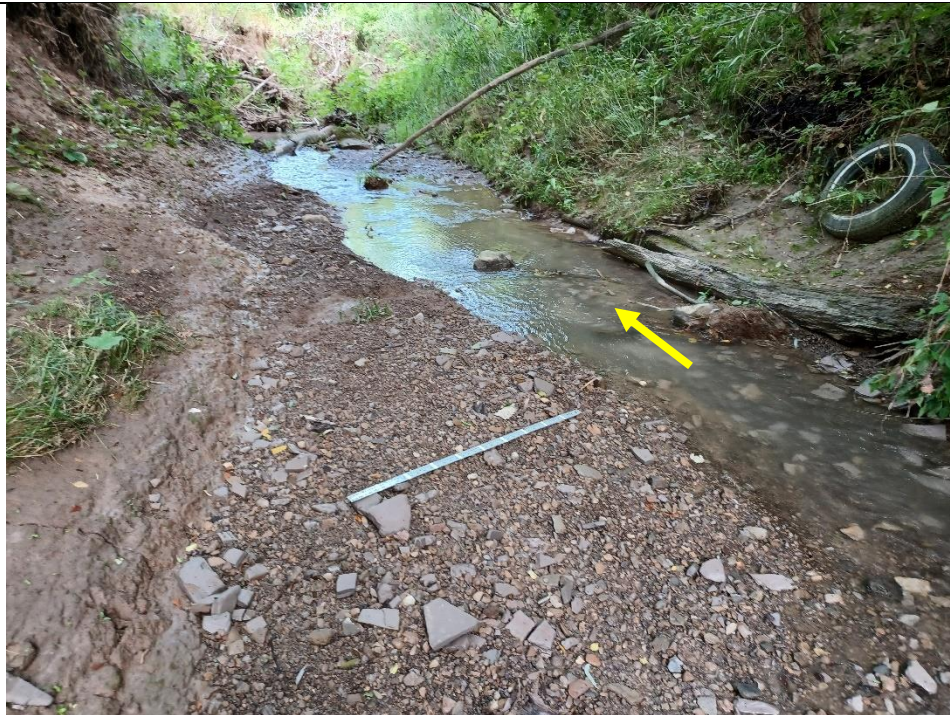
Photo 8

Riffle-pool sequencing was present with bed materials ranging from clay and silt to cobbles in the riffles and clay, silt and sand in the pools.

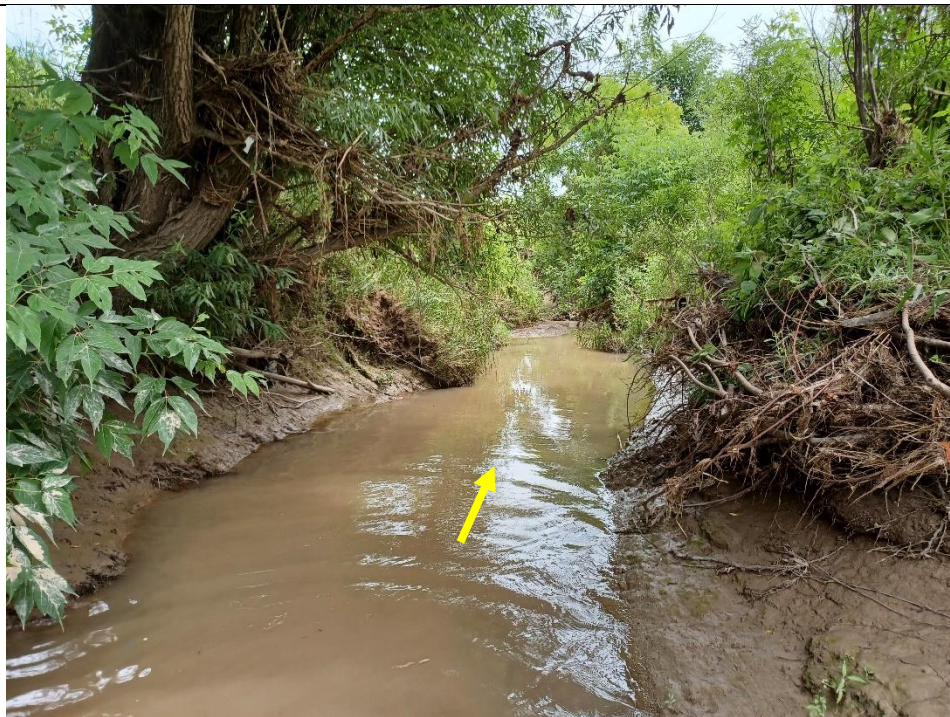
Photo 12

Bank angles ranged from 60° to 90° with localized undercutting. Bank material was comprised of clay and silt.

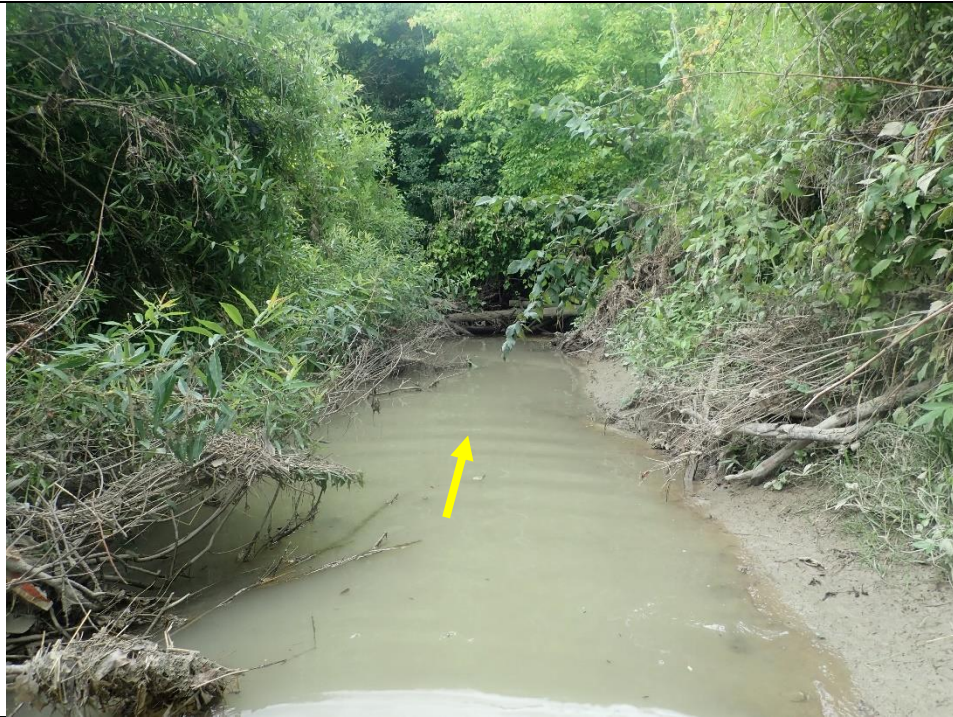
Photo 13

Photograph taken at upstream extent of Reach SC-A-5. This was a confined channel with continuous riparian coverage of mature trees.

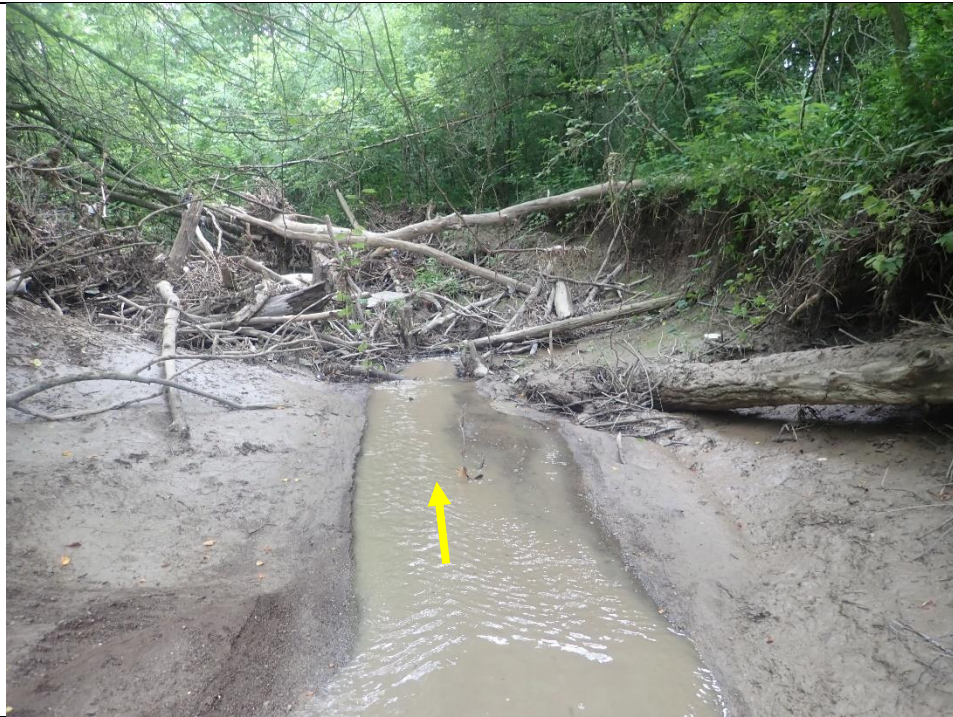
Photo 14

This Reach had a high density of woody debris jams both in the channel and the cutbank.

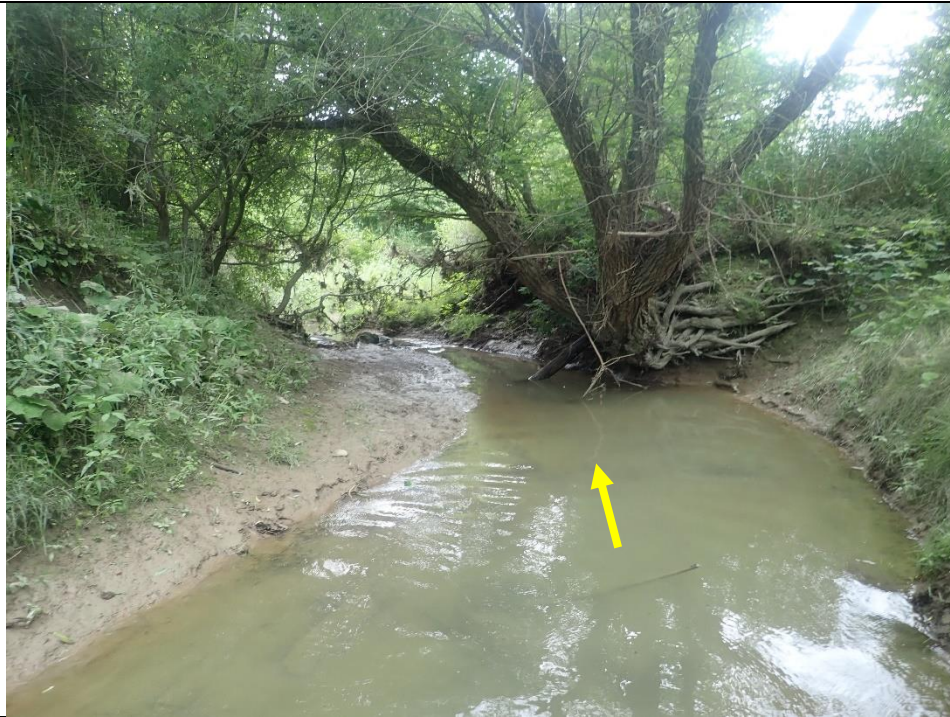
Photo 15

Substrate within this reach ranged from exposed till to small cobbles.

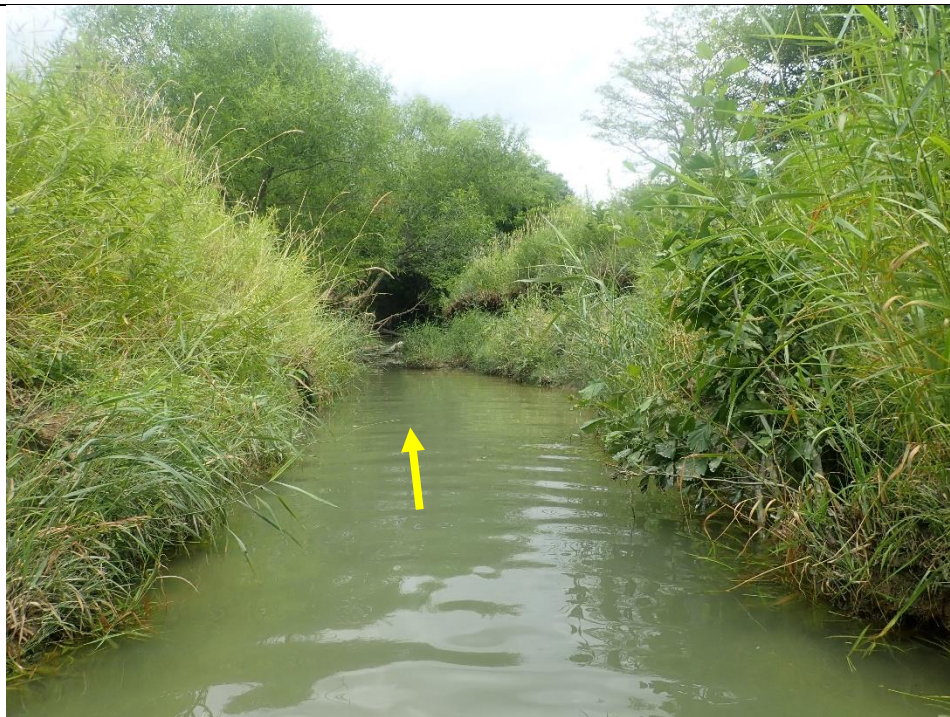
Photo 16

This Reach became deeper and wider downstream and riffle-pool sequencing became absent as the channel was dominated primarily by runs.

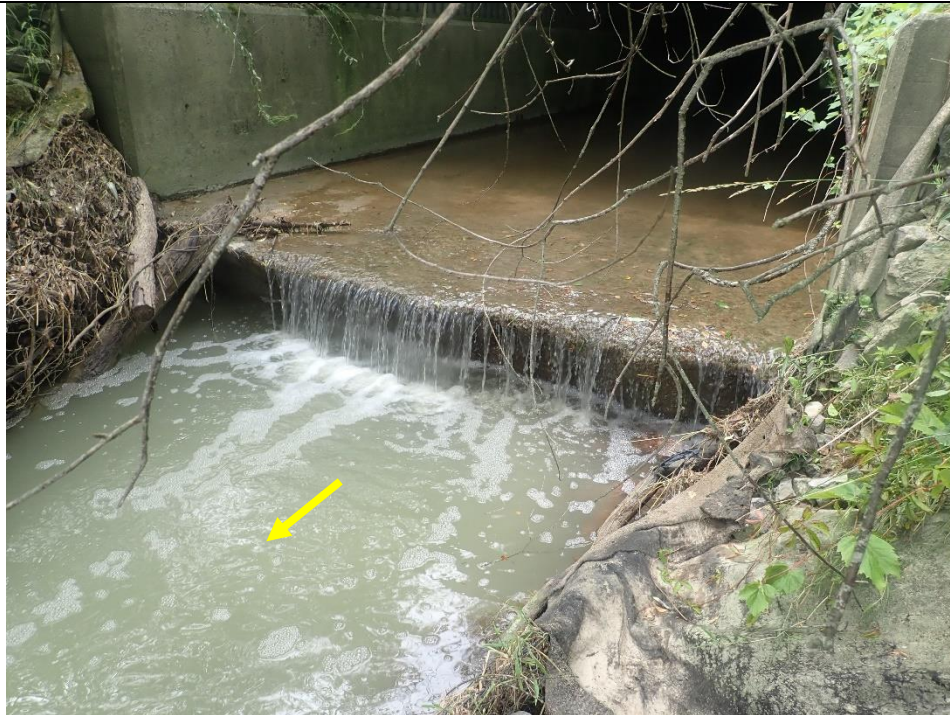
Photo 17

Reach SC-A-6 is approximately 480 m in length and is defined as a low-gradient reach which originates at the culvert which conveys the channel beneath a CN railway. The culvert structure consists of a concrete headwall and apron, with gabion basket wingwalls. The gabion basket wingwalls are in poor condition and emptying. The reach is a partially confined valley reach with a narrow riparian corridor. The channel exhibits a meandering planform with a low gradient. A tractor crossing has disturbed the channel at this location. The reach is defined by being highly silted, especially in the pools. At the time of field observation, water was highly turbid and opaque with sediments and the reach is pool morphology dominant. Pools are up to 1.5 m in depth and there is woody debris within the channel and cutbanks with evidence of recent treefall. The banks along this reach are unstable but well-vegetated.

Reach SC-A-6 began at an outlet beneath a railroad crossing. A scour pool had formed downstream of the outlet and undermined gabion baskets were present.

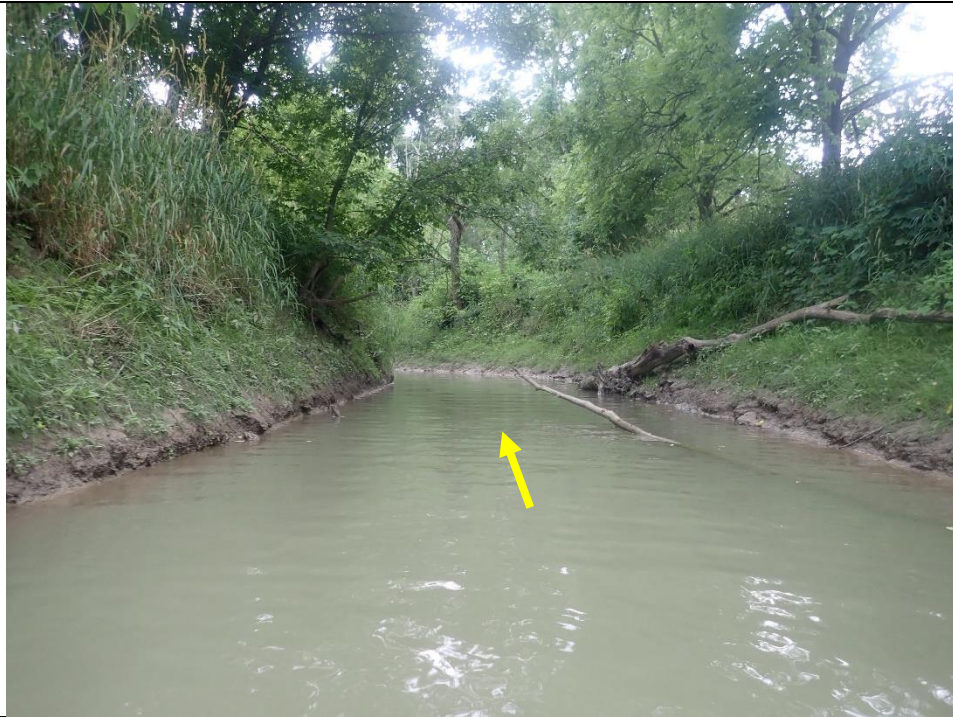
Photo 19

Bank angles ranged from 60° to 90° and average bankfull widths and depths were 5.15 m and 1.32 m, respectively

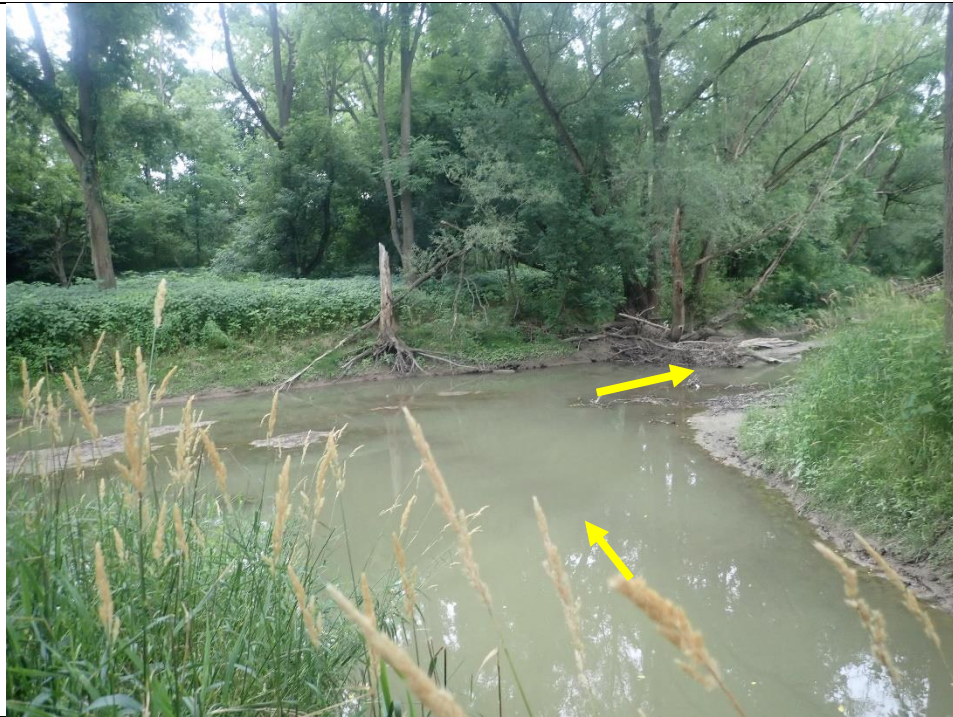
Photo 20

Photograph taken at the downstream extent where Reach SC-A-6 conflues with Fairchild Creek.

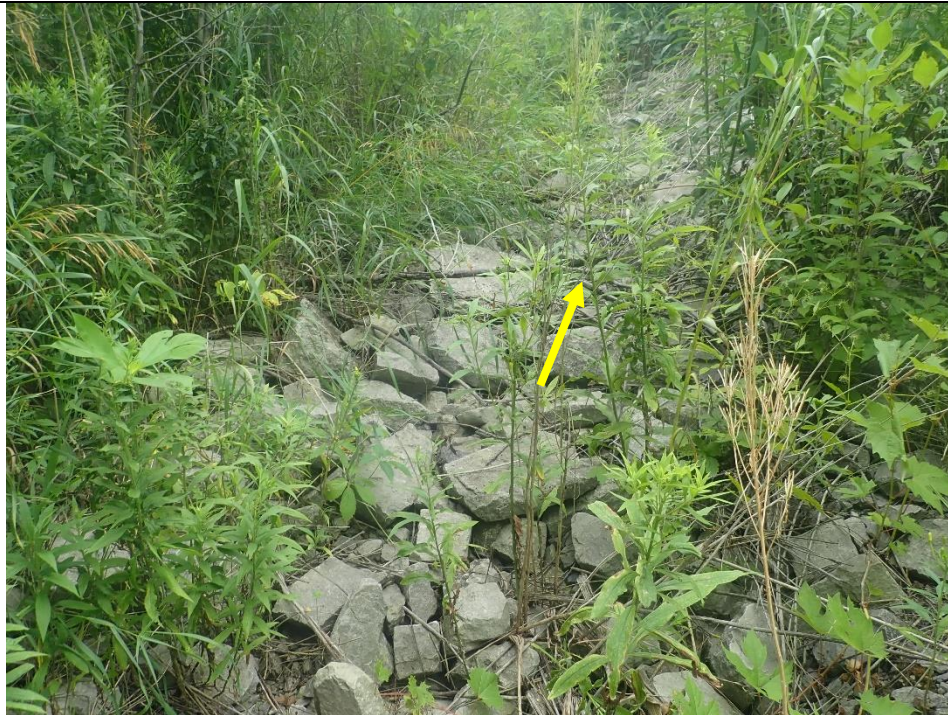
Photo 21

Reach PO12 initiates adjacent to a railroad crossing and flows southeast to Fairchild Creek. This is feature was characterized as a headwater reach within an unconfined floodplain.

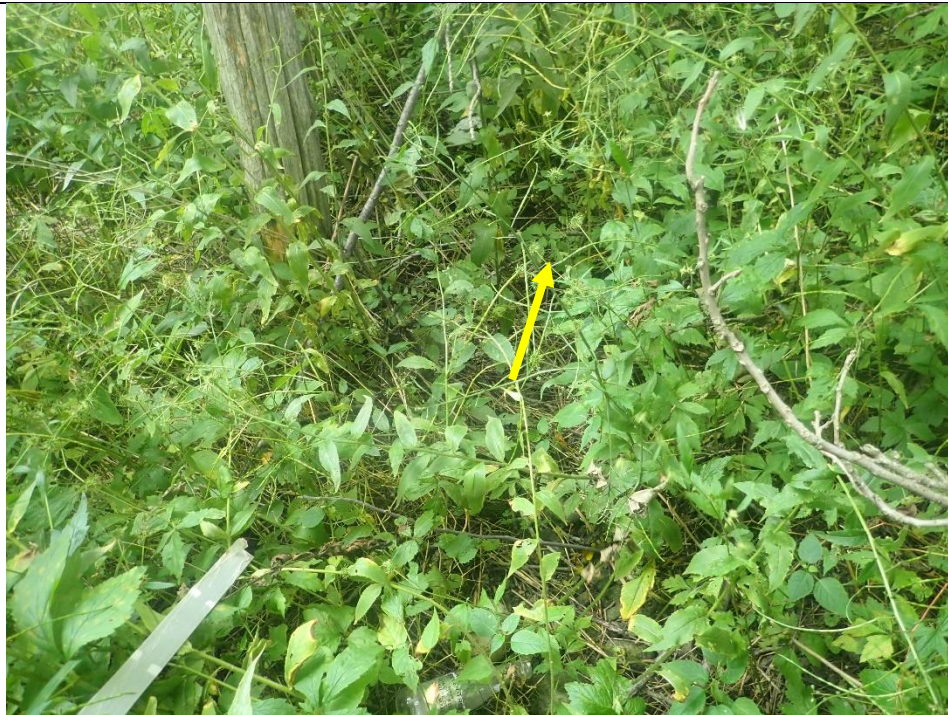
Photo 22

The channel stemming from **PO12** is best characterized as a vegetated swale feature with poorly defined banks. No flow was observed at the time of assessment. Where the channel flows alongside the railway, the bed substrate of this feature consists of rip-rap and stone.

This Reach had poorly defined bed and banks with heavy vegetation encroachment into the channel.

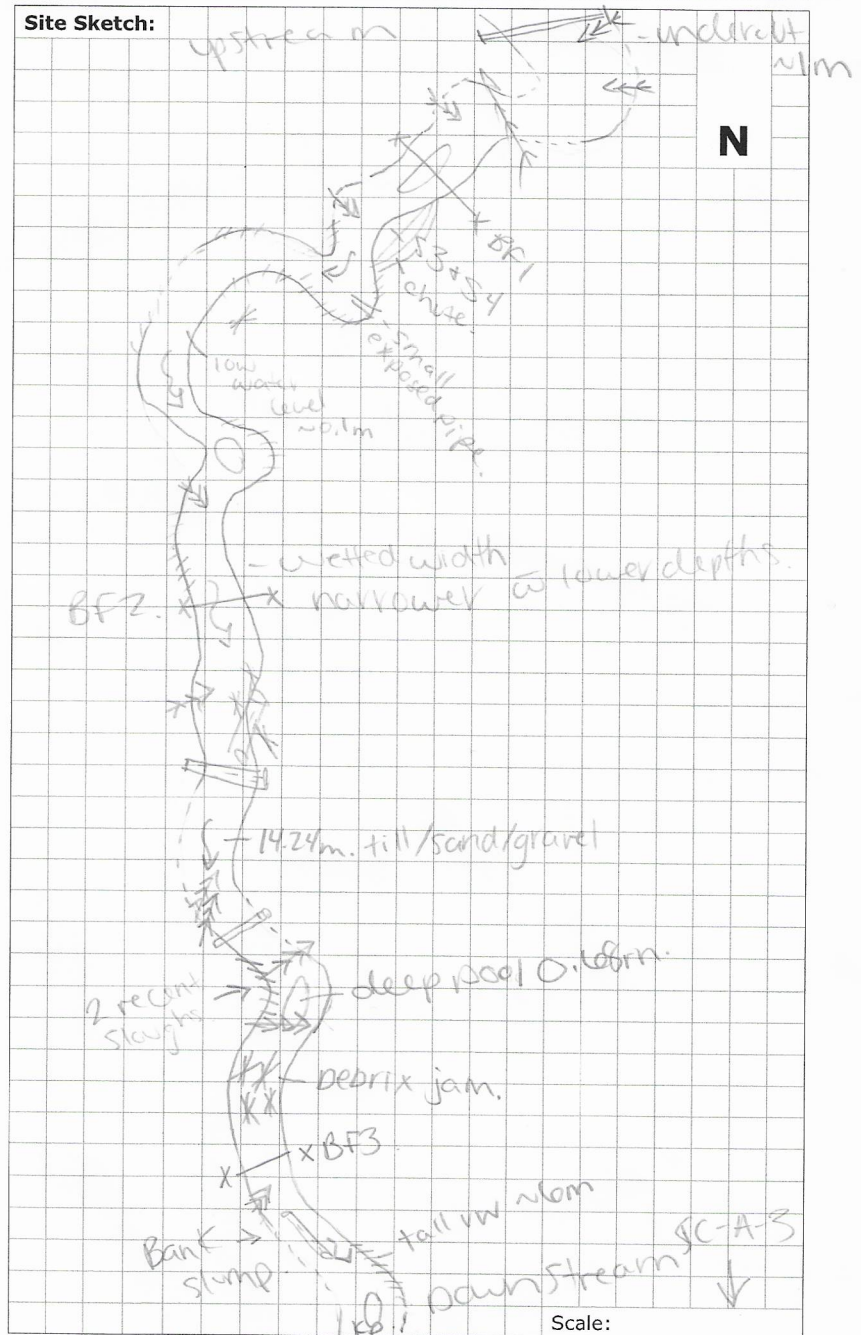
- Valley wall contact along both sides of reach
- exposed till predominant through channel.
- large undercuts common.
- exposed tree roots common

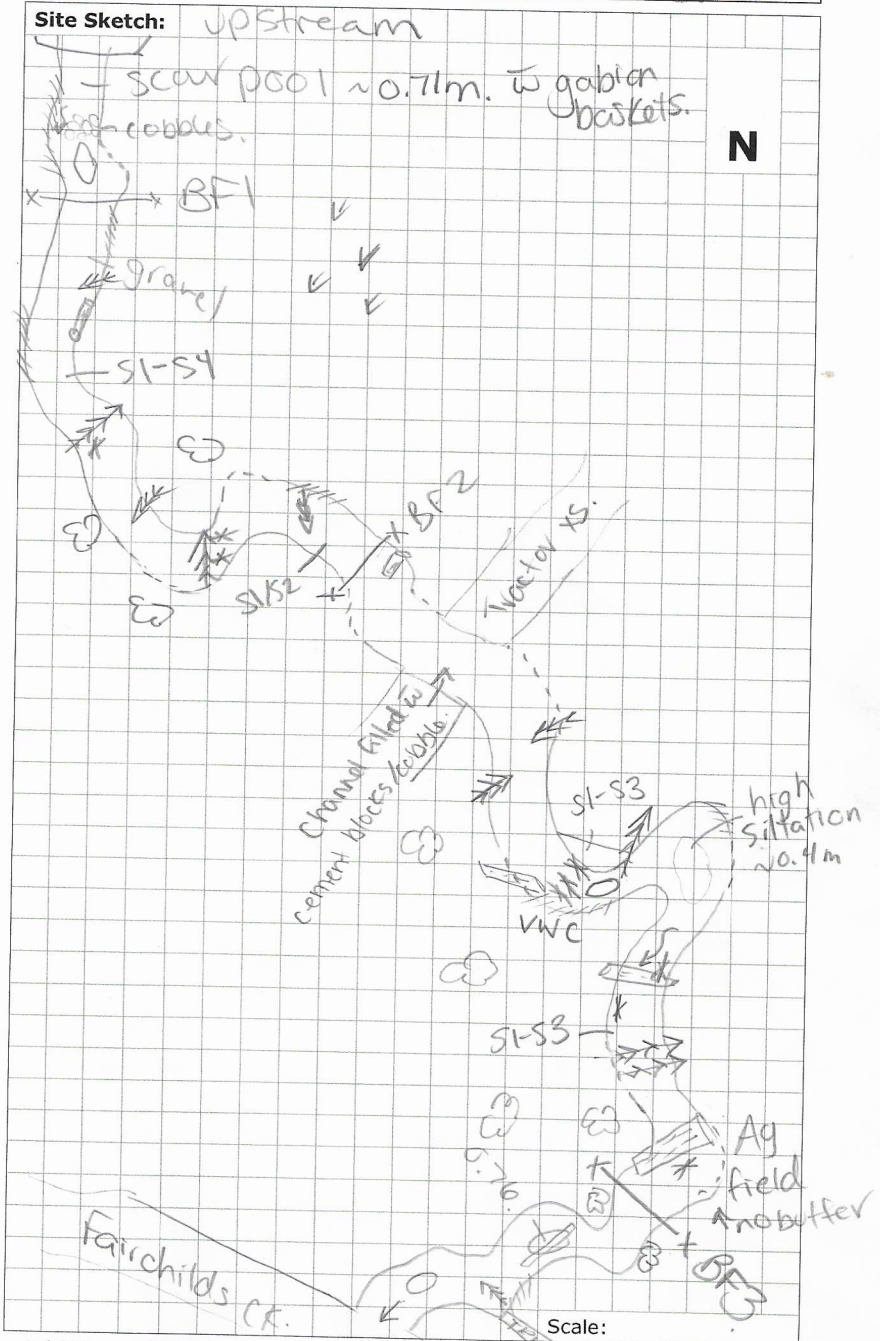
- Basal scall common throughout channel.
- predominantly runs, few pools/riffles.
- valley wall contact in some locations.
- exposed clay evident in channel/banks
- siltation common ~0.42cm in some locations.

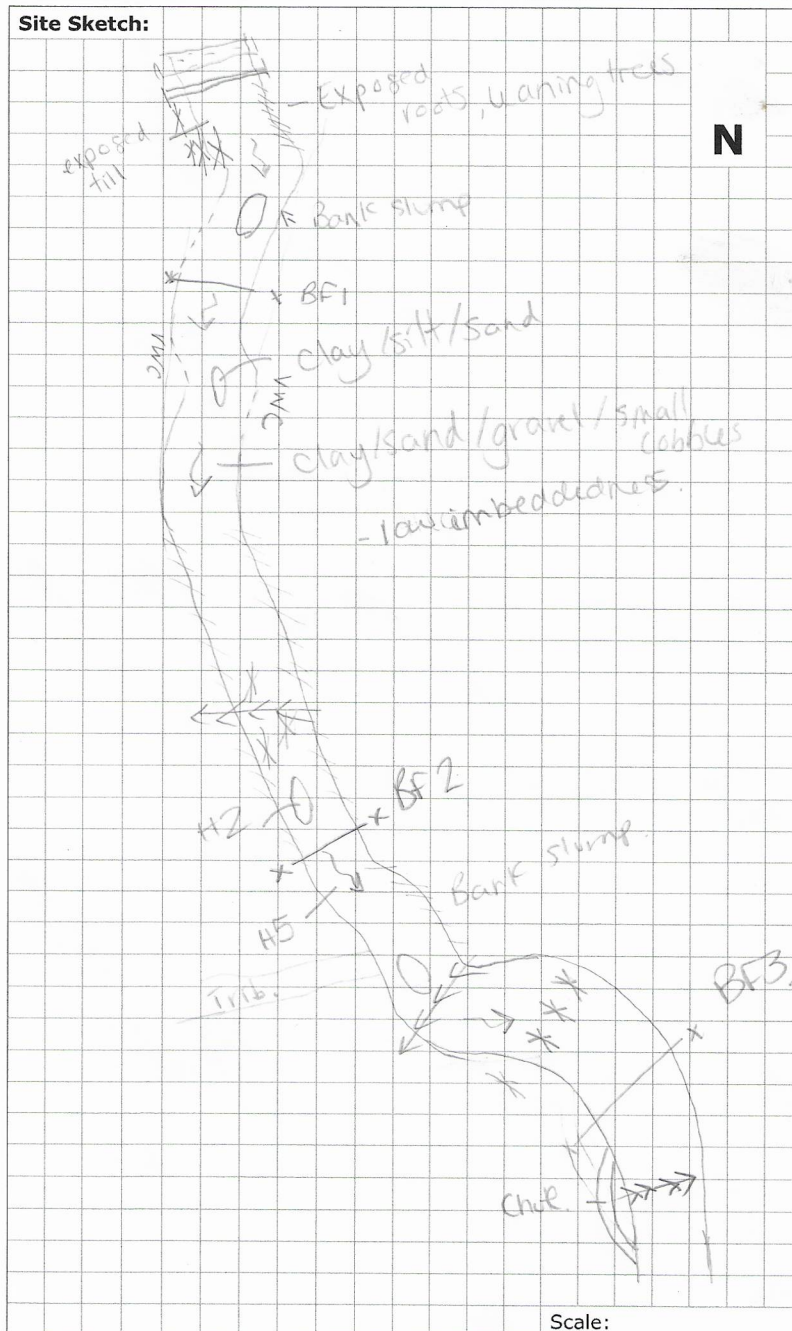
- Exposed till for most of channel
 - sand deposits common

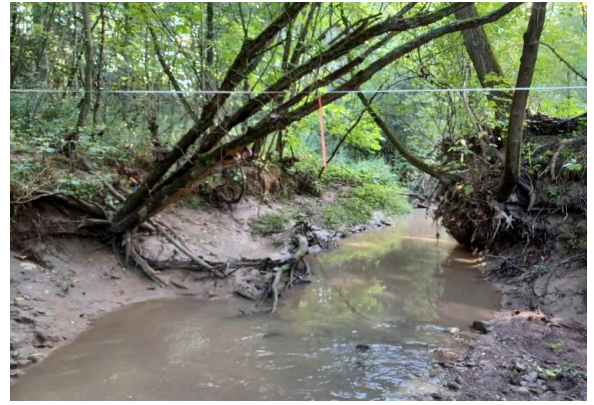
Representative Cross-Section 1

Photograph at cross section 1 (looking upstream)

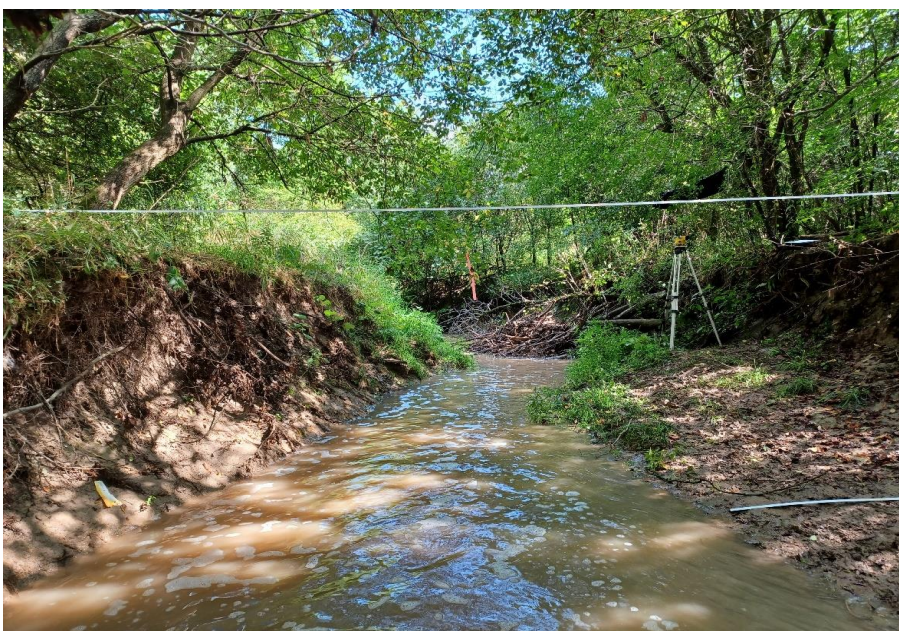
Cross Section 5 - Facing Downstream

Reach SC-A-5 was an irregularly meandering channel with a moderate gradient, situated within a confined valley. Adjacent land use consisted of forests. Riparian cover was continuous and spanned over 10 channel widths, primarily consisting of trees. Bed substrate was comprised of clay to cobble sized particles. The banks were sparsely vegetated and showed signs of heavy erosion and undercutting throughout the reach. Few locations along the reach had contact with the valley wall. A high density of woody debris was present within the channel and cutbanks at the time of assessment.
